**ORDER
ISSUED UNDER THE
WATER POLLUTION CONTROL ACT
WEST VIRGINIA CODE, CHAPTER 22, ARTICLE 11**

TO: Benedum Airport Authority
Attn: Richard Rock
2000 Aviation Way
Bridgeport, WV 26330

DATE: March 14, 2022

ORDER NO.: 10033

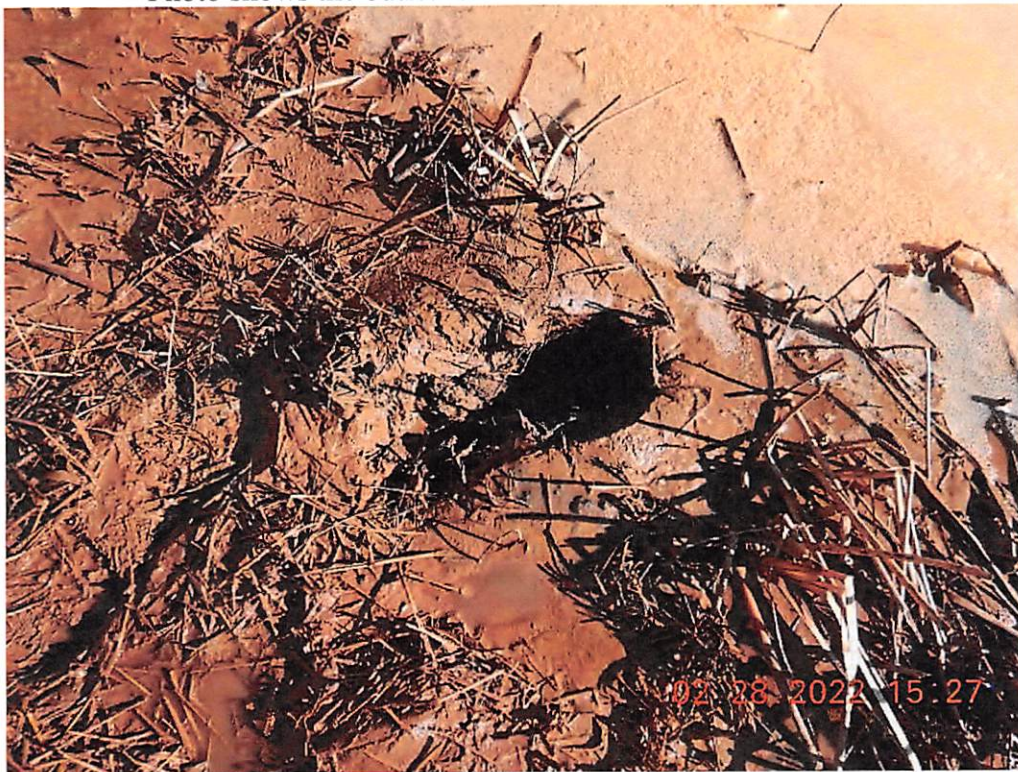
- i. 47CSR2 Section 3.2.b.- Benedum Airport Authority caused conditions not allowable in waters of the State by creating distinctly visible settleable solids in the UNT of Peddler Run and the UNT of Ann Run.

Photo shows sediment deposits in a UNT of Ann Run at the outlet for Pad 1.

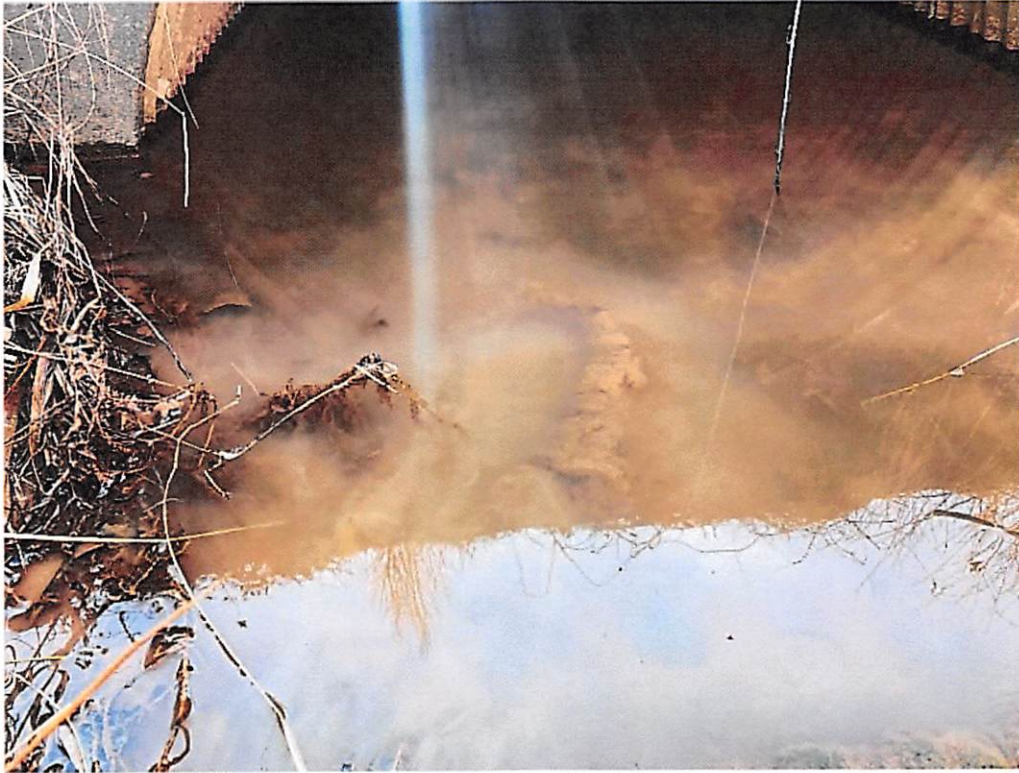
Photo shows sediment deposits in a UNT of Peddler Run at the outlet for Pad 2.
